Manhole Inspection Summary

Manhole # S25E__016MH

Insp Date: **8/9/07 9:17 AM**

Location Address: **1047 LEXINGTON ST**

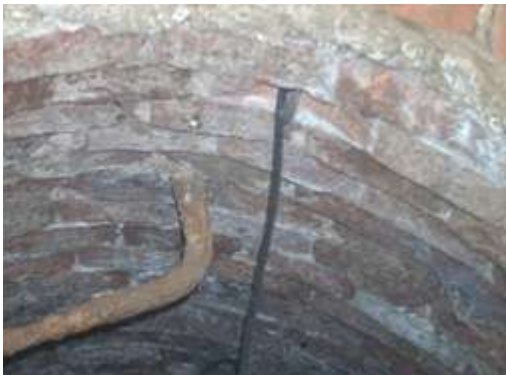
Comments **USED TO BE A SEVERN TRENT FLOW MONITOR IN THIS MANHOLE**

FLOW MONITOR CABLE

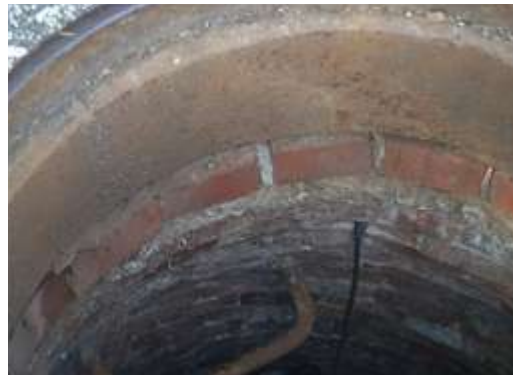
Defect 2

Condition: ☐ Sound ☐ Cracked ☐ Root Intrusion ☒ **Loose Brick** ☐ Deteriorated

LOOSE CHIMNEY BRICKS

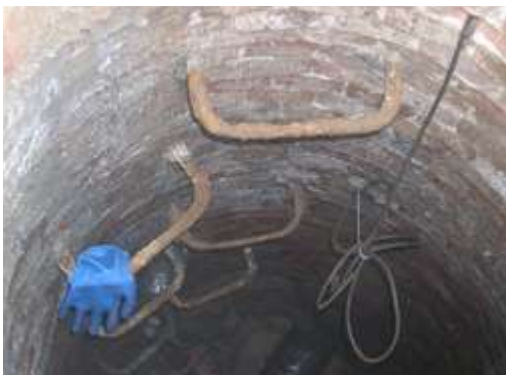
Defect 1

Count: **7** Missing: **0** ☒ **Corroded**

CORRODED STEPS

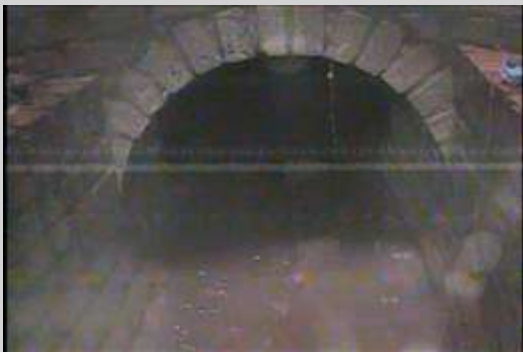
12 O'Clock Outflow

24 in. Circular Gravity Sewer
Pipe Out @ 12 O'Clock

Pipe Height: **25.2** (in.) Rod and Bar (Angled)
Pipe Material: **Clay** ☐ Pipe Lined
Invert Depth: **13.32** (ft.) Flow Characteristics: **Slow**
Deposits: ☒ None ☐ Mud ☐ Sludge ☐ Debris ☐ Grease
Silt Depth: (in.) Deposits Extent:
Infiltration: **None** Pipe Seal Cond: **Sound**

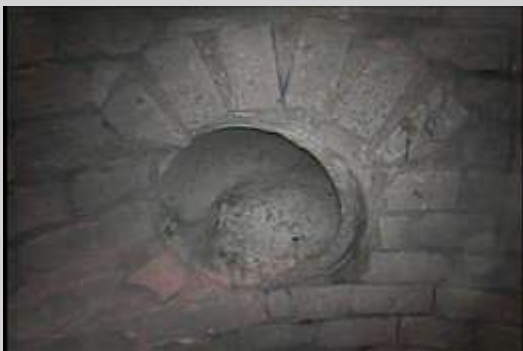
5 O'Clock Inflow

8 in. Circular Gravity Sewer
Pipe In @ 5 O'Clock

Pipe Height: **7.2** (in.) Rod and Bar (Angled)
Pipe Material: **Clay** ☐ Pipe Lined
Invert Depth: **9.19** (ft.) Flow Characteristics: **Fast**
Deposits: ☒ None ☐ Mud ☐ Sludge ☐ Debris ☐ Grease
Silt Depth: (in.) Deposits Extent:
Infiltration: **None** Pipe Seal Cond: **Sound**

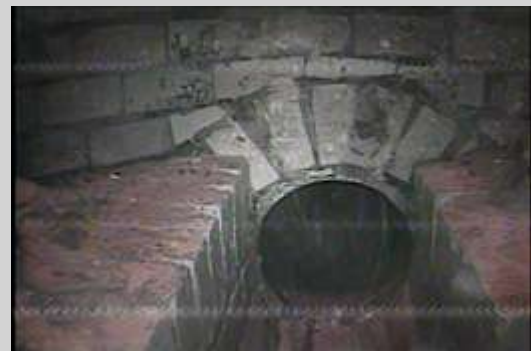
Drop In @ 5 O'Clock

Drop: **Outside** Rod and Bar
Angled: **Yes** Reading: **11.05** (ft.)
Inv Depth: **12.05** (ft.)
Drop Condition: **Open**

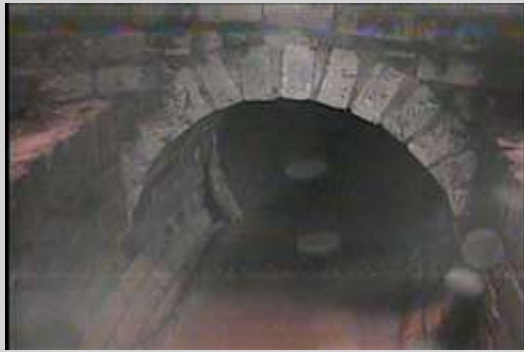
8 O'Clock Inflow

24 in. Circular Gravity Sewer

Infiltration: **None** Pipe Seal Cond: **Sound**
